Manhole Inspection Summary

Manhole # S37EE1030MH

Insp Date: **2/21/07 9:44 AM**

Location Address: **3928 39TH ST**

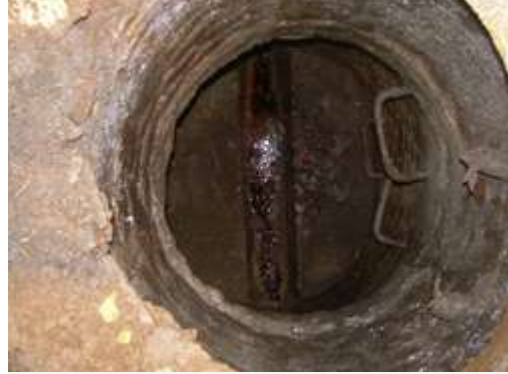
Top View

Adjustment deterioration and infiltration. Corroded steps. Evidence of surcharge - Bench debris.

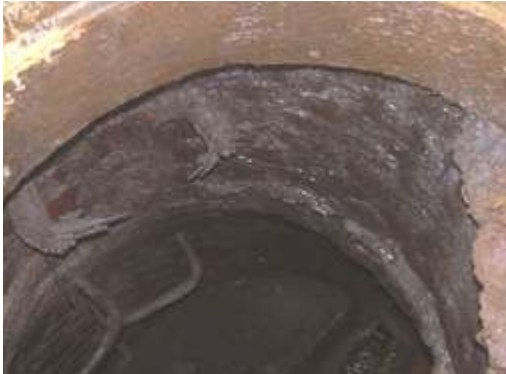
Defect

Frame leaks. Adjustment, Corbel and Barrel infiltration.

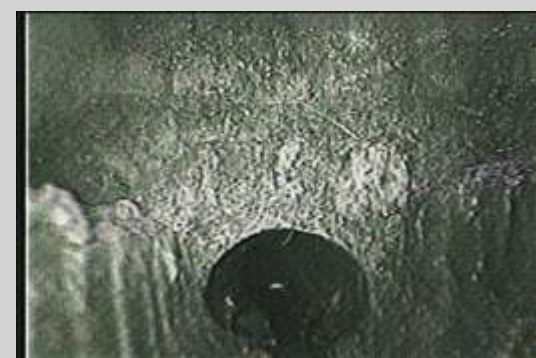
8 in. Circular Gravity Sewer Pipe Out @ 12 O'Clock

Barrel deterioration, root intrusion and infiltration.

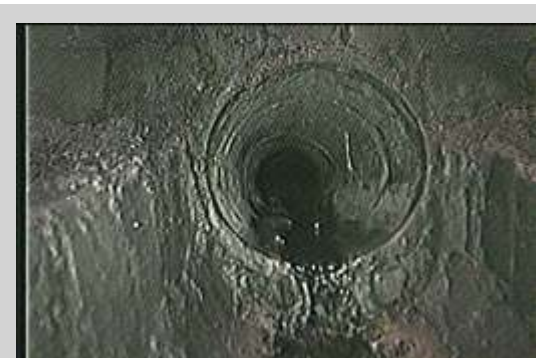
8 in. Circular Gravity Sewer Pipe In @ 6 O'Clock

Barrel deterioration, root intrusion and infiltration. Channel deterioration and root intrusion. Bench root intrusion.
